**Pipe penetration waterproofing with  
AQUAFIN®-2K or AQUAFIN®-2K/M**  
(Load: ground moisture and non rising seepage water )

**MSASA**  
Construction Solutions for Africa

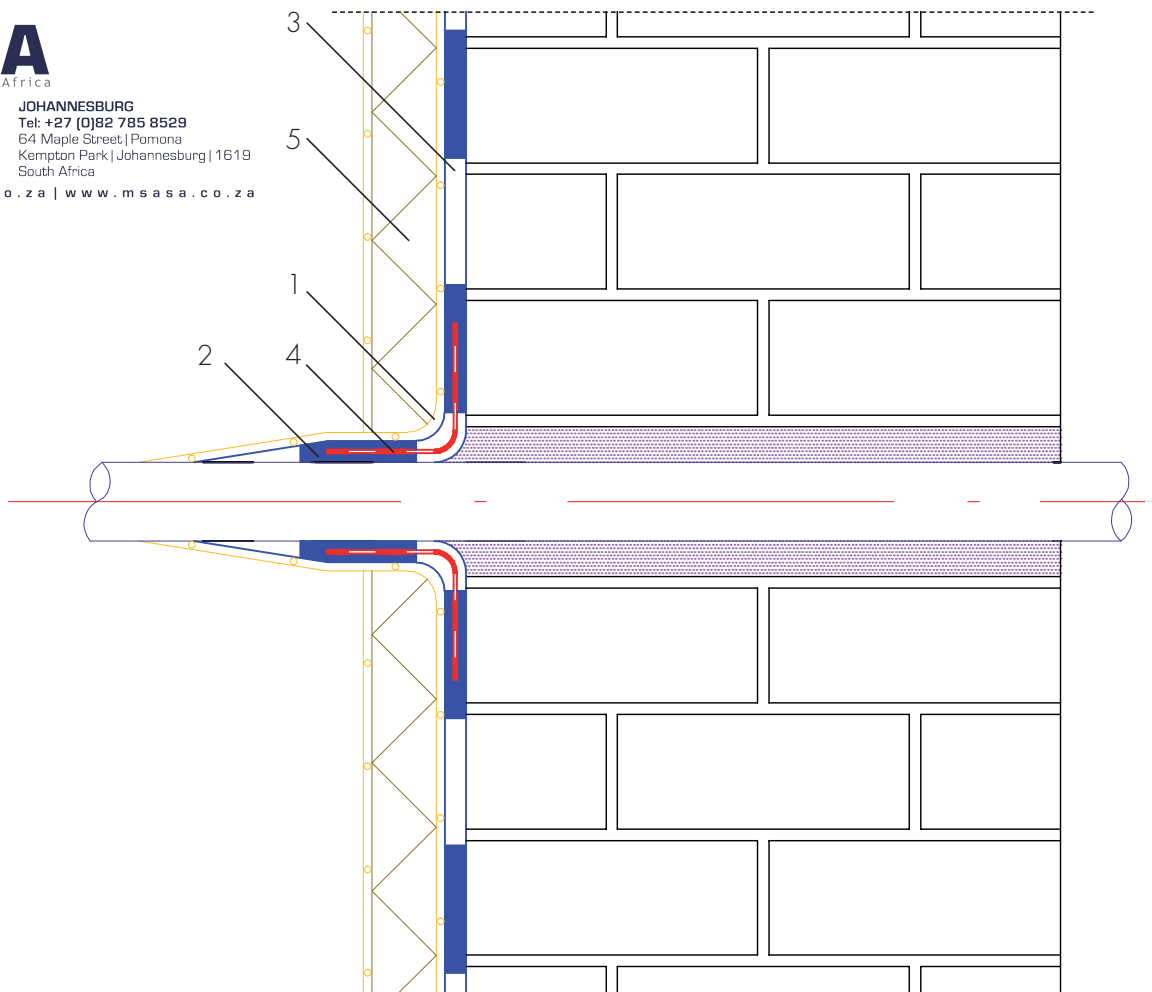
- 1 Cove with  $R > 4$  cm formed with ASOCRETRN cementitious mortar
- 2 Pipe surface abraded and degreased with Universal Cleanser
- 3 AQUAFIN-2K or AQUAFIN-2K/M waterproofing
- 4 ASO-Joint-Sleeve sealing gasket
- 5 Waterproofing protection layer with INA Schutz- und Drainelement (INA-Protective board)
