Interior swimming pool wall/floor joint (thin bed)

Exposure class B

MSASA
Construction Solutions for Africa

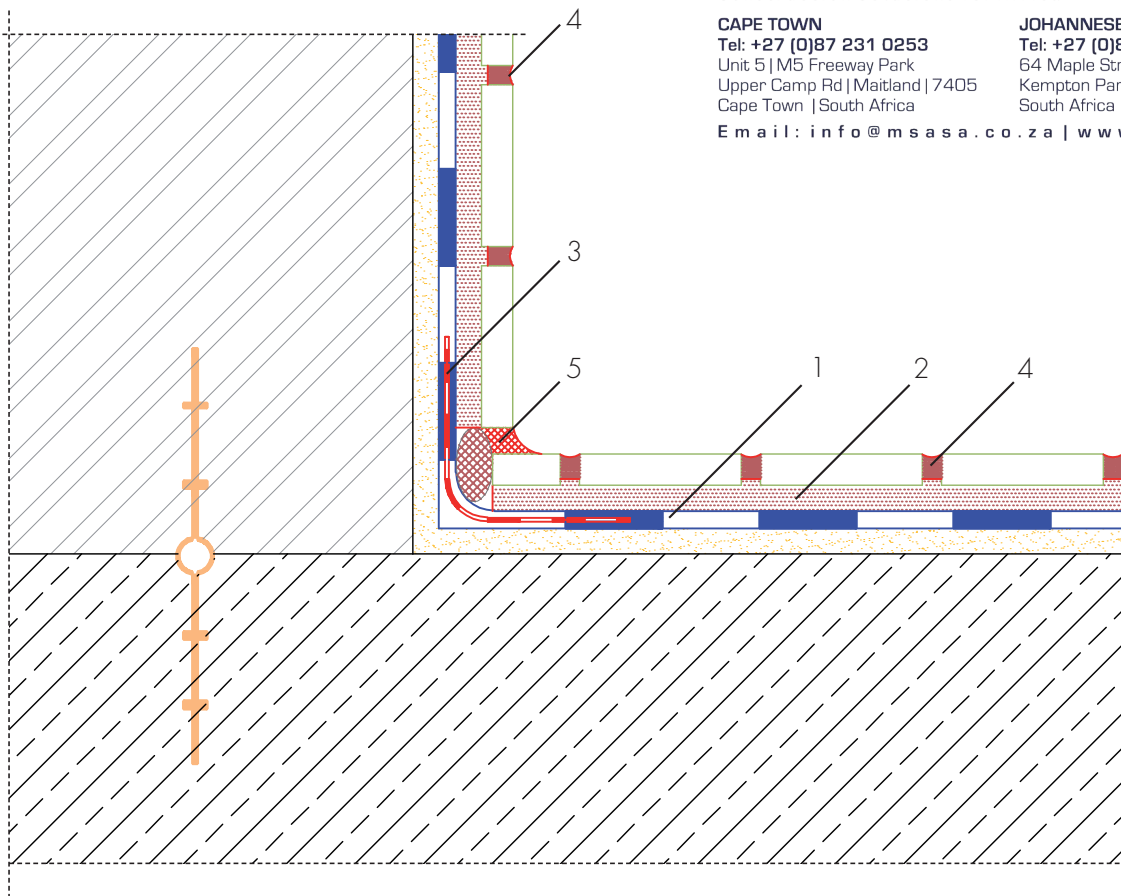
- 1 AQUAFIN-2K/M waterproofing
- 2 UNIFIX-2K/6 or SOLOFLEX tile adhesive
- 3 ASO-Joint-Tape-2000-S
- 4 ASODUR-EK98 or HF05-Brilliantfuge tile grout
- 5 ASO-backer rod and elastic sealer
ESCOSIL-2000-UW caulk
